Dam ID: HI00006  
Waikaia

Inspection No: \_\_\_\_\_  
Date: 03/22/2006

STATE OF HAWAII - DLNR  
VISUAL DAM SAFETY INSPECTION SHEET

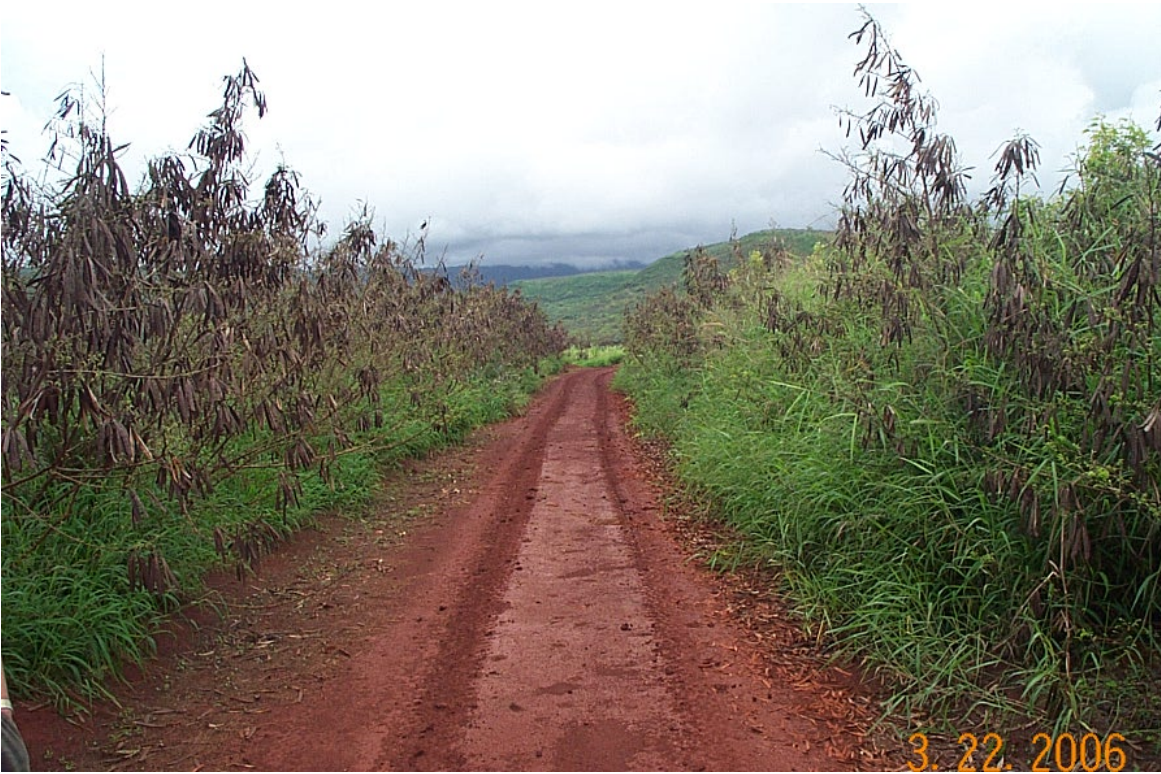
- ☒ l. Section of the crest has tall grass. Should routinely clear vegetation..

HI00006 - Waikaia Reservoir: View of the dam crest. Note vegetation on both sides of road.

1. Clear spillway approach channel of vegetation.
2. Owner should continue with removal of vegetation on the upstream and downstream slopes and crest. The slopes should be clear and visible for inspection. If existing trees have been allowed to grow so large in some cases that there is concern that seepage and piping (i.e. internal erosion) along root systems may develop. There is additional concern that cutting and killing the trees will lead to rotten roots and greater potential for such seepage and piping. A more in depth evaluation of the condition should be performed to determine how best to remediate the condition.

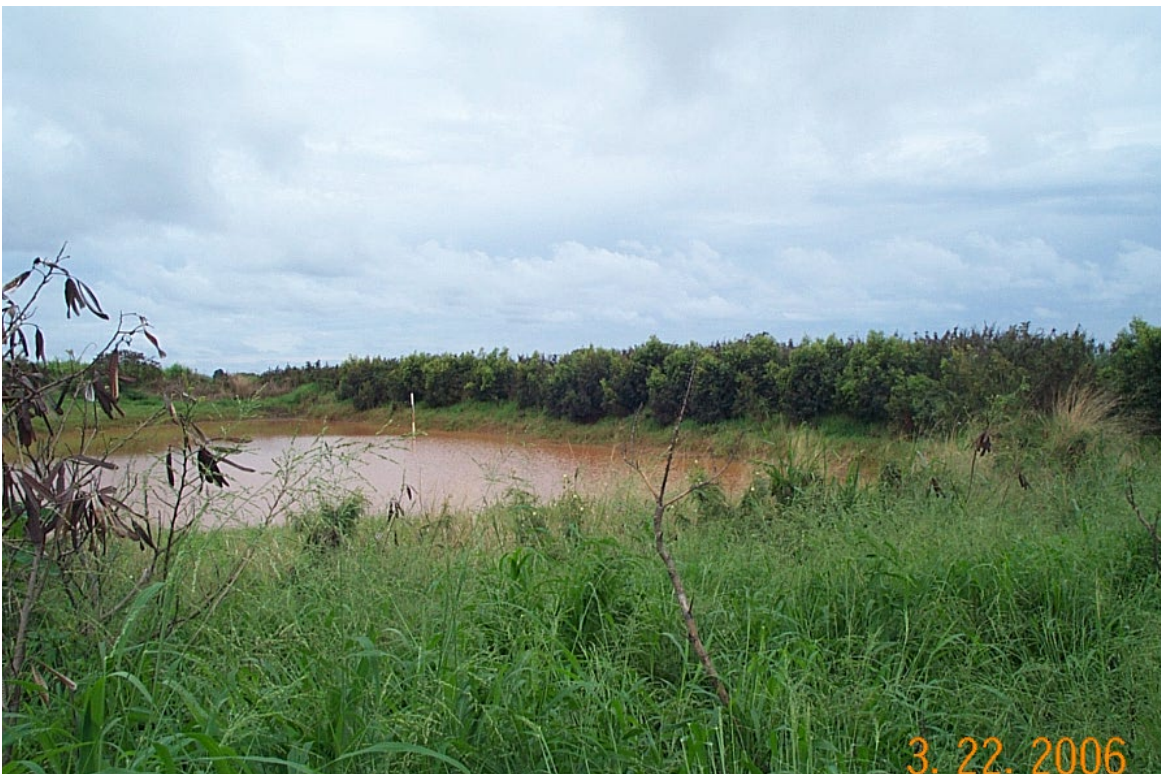
Vegetation: ☐ None ☐ Low Ground Cover ☒ Bushes or Tall Grass ☒ Trees # lots ☒ <6" ☐ >6" & <20" ☐ >20"

HI00006 - Waikaia Reservoir: View of the upstream slope of the dam. Note trees on the slope.

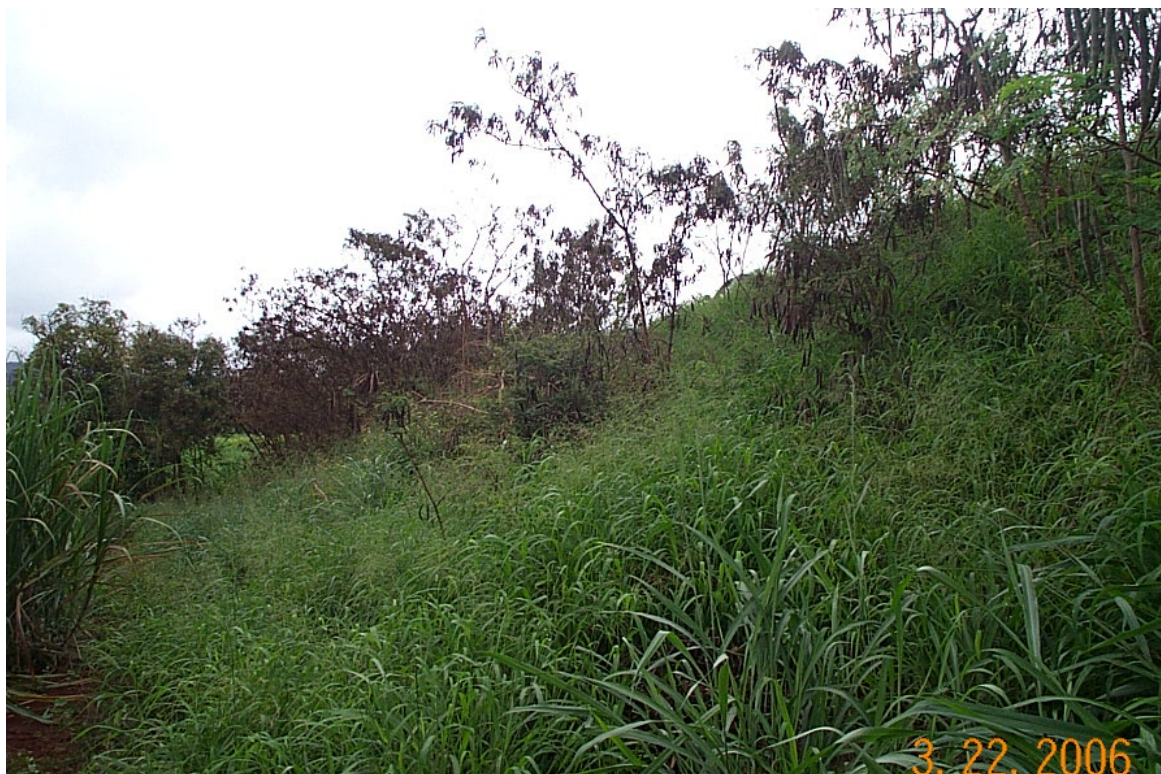
Vegetation: ☐ None ☐ Low Ground Cover ☒ Bushes or Tall Grass ☒ Trees # lots ☒ <6" ☐ >6" & <20" ☐ >20"

- ☐ a. The downstream slope was not inspected.
- ☐ b. The downstream slope appeared to be in satisfactory condition, no corrective actions are required at this time.
- ☒ c. The downstream slope appeared to be in fair to poor condition and requires corrective action.
- ☐ d. The downstream slope appeared to be in unsatisfactory condition and not expected to fulfill its intended function. Urgent corrective action is required.

HI00006 - Waikaia Reservoir: Downstream slope of the dam. Note vegetation on the slope.

- ☐ j. The slope was very steep, around a 1 to 1 slope, further study is required to verify slope stability.
- ☒ k. Owner should continue vegetation removal every two years or as necessary to keep clear.
